# **Issues and Consequences of Atomic Oxygen Undercutting of Protected Polymers in Low Earth Orbit**

Bruce A. Banks, Aaron Snyder, Sharon K. Miller  
National Aeronautics and Space Administration  
Glenn Research Center  
Cleveland, Ohio 44135

1. AGENCY USE ONLY (Leave blank)		2. REPORT DATE April 2002		3. REPORT TYPE AND DATES COVERED Technical Memorandum
4. TITLE AND SUBTITLE  Issues and Consequences of Atomic Oxygen Undercutting of Protected Polymers in Low Earth Orbit			5. FUNDING NUMBERS  WU-755-A4-06-00

9. SPONSORING/MONITORING AGENCY NAME(S) AND ADDRESS(ES)  National Aeronautics and Space Administration Washington, DC 20546-0001			10. SPONSORING/MONITORING AGENCY REPORT NUMBER  NASA TM-2002-211577

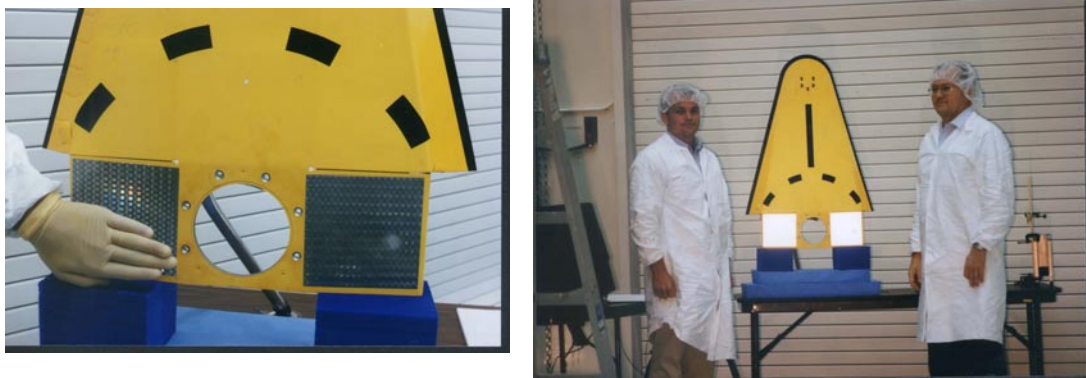
The EURECA spacecraft, which was deployed into low Earth orbit on August 2, 1992 and retrieved after 11 months on June 24, 1993, was exposed to an atomic oxygen fluence of approximately  $2.3 \times 10^{20}$  atoms/cm<sup>2</sup> [2]. To assist in its retrieval, the spacecraft used two thin adhesively mounted acrylic optical retroreflectors for laser range finding. Prevention of atomic oxygen attack of the retroreflector surfaces, which would have degraded the specularity of the reflectance, was accomplished by coating the retroreflector surface with a ~1000 Angstrom thick film of sputter deposited SiO<sub>2</sub> filled with 8% fluoropolymer (by volume). The LEO exposed and retrieved retroreflector was inspected and optically characterized. The results indicated that the protective coating provided excellent protection and the retroreflector performed as planned except in a small 3 cm patch where the protective coating was accidentally abraded prior to flight as a result of handling during preflight ground integration [3]. Figure 1 shows a close up picture of the retroreflectors as well as their appearance during illumination after retrieval.

Figure 1.—EURECA retroreflectors after retrieval close up and during illumination.

The drastic differences in atomic oxygen protection provided by the same SiO<sub>2</sub> coating filled with 8% fluoropolymer on the EURECA retroreflectors and the ISS retroreflectors is thought to be due to drastic differences in the protective coating defect densities. The acrylic EURECA retroreflectors surfaces were extremely smooth as required to produce high fidelity specular reflections. Such smooth surfaces result in low-defect-density protective coatings that have also been demonstrated, in ground laboratory testing, to perform acceptably. For example smooth surface (air-cured side) Kapton® when coated with 1300 Angstrom thick SiO<sub>2</sub> resulted in ~ 400 pin window defects/cm<sup>2</sup>. However, the same coating on the rougher surface (drum-cured side) has been found to result in 3500 pin window defects/cm<sup>2</sup> [1]. Similar experiences with graphite epoxy composite surfaces formed by casting against another smooth surface produce defect densities of ~262,300 defects/ cm<sup>2</sup> [3]. Surface leveling polymers applied over such surfaces have been found to reduce the defect densities by an order of magnitude to ~22,000 defects/cm<sup>2</sup> [3].

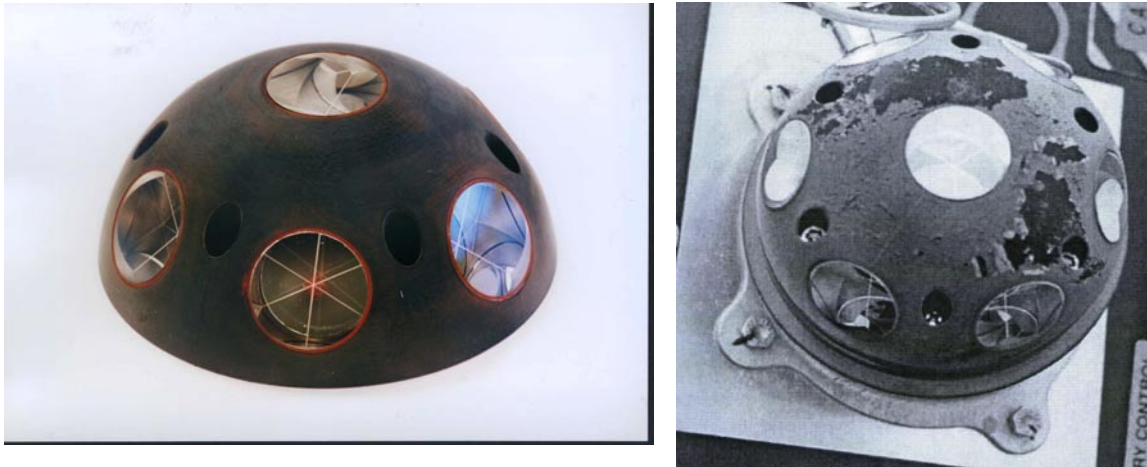
ISS retroreflectors, which serve in a similar role as the EURECA retroreflectors, have been used which employ a glass corner cube retroreflector that is housed in a 10 cm diameter Delrin® 100 polyoxymethylene mount. Polyoxymethylene is an oxygen rich polymer is readily attacked by atomic oxygen. To prevent atomic oxygen attack of the Delrin®, the machined polymer surfaces were coated by the same processes, in the same facility and with the same ~1000 Angstrom thin film of sputter deposited 8% fluoropolymer-filled SiO<sub>2</sub> that was used for the EURECA retroreflector. Several of these retroreflectors have been mounted on the external surfaces of the ISS structures at various locations that are exposed to LEO atomic oxygen. Figure 2 shows a close up of one of the coated retroreflectors prior to use on ISS in space as well as a photograph from space of a retroreflector after attack by atomic oxygen. It is clear from the in-space photograph that the coating was only partially attached allowing direct atomic oxygen attack of the unprotected areas.

Figure 2.—ISS retroreflectors prior to launch and during use in space on ISS after atomic oxygen attack.

The machining of the Delrin® 100 (polyoxymethylene) retroreflector mount surfaces produces machine marks or rills in the surface resulting in a highly defected atomic oxygen protective coating. Such rills allow atomic oxygen to oxidize and undercut the high erosion yield Delrin®, causing the coating to gradually be left as an unattached gossamer film over the retroreflector mount which could be easily torn and removed by intrinsic stresses and thruster plume loads. The use of smoother surfaces, surface-leveling coatings over the machined Delrin® or use of alternative atomic oxygen durable materials could potentially eliminate the observed problem.

Atomic oxygen protective coatings have been developed and used in space that perform acceptably. However, rough surface substrates cause defects in the protective coatings that allow atomic oxygen to react and gradually undercut the protective coating. In the case of machined Delrin® ISS retroreflector mounts, such roughness has lead to detachment of portions of the protective film covering the retroreflector mount.

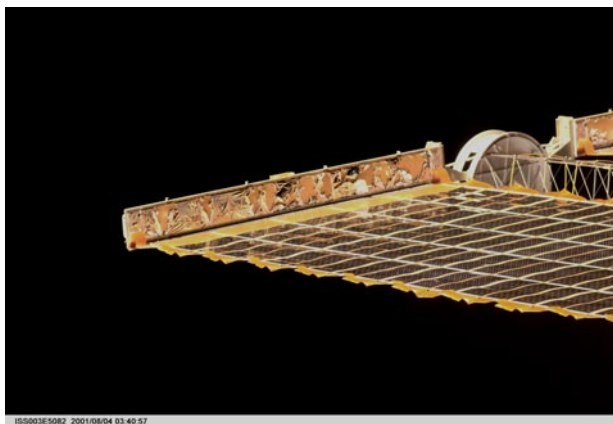
a. Distant photo

Prior to deployment, the ISS photovoltaic arrays were folded into a box that allows the array to be compressed in a controlled manner against a cushion of open pore polyimide foam that was covered with a 0.0254 mm thick aluminized Kapton® blanket. The Kapton® was coated on both surfaces with 1000 Angstroms of vacuum deposited aluminum. The array was exposed to the LEO atomic oxygen environment from December 2000 through December 2001. Photographs of the array, taken in orbit, indicated that the Kapton® blanket had been almost completely oxidized leaving only the thin largely torn aluminization in place as shown in Figure 3.

Figure 3.—ISS photovoltaic array showing effects of atomic oxygen erosion of the double aluminized Kapton® blanket cover for the ISS photovoltaic arrays box

The lack of atomic oxygen protection provided by the aluminized Kapton® blanket cover for the ISS photovoltaic arrays box cushion is thought to be due to the trapping of atomic oxygen between the two aluminized surfaces on the 0.0254 mm thick Kapton® blanket. Defects in the space exposed aluminized surface allow atomic oxygen to erode undercut cavities. If the undercut cavity extends downward to the bottom aluminized surface, then the atomic oxygen becomes somewhat trapped and has multiple opportunities for reaction until it either recombines, reacts, or escapes out one of the defects in the aluminization. This eventually results in a complete loss of the Kapton® with only the aluminized thin film remaining. The vacuum deposited aluminum has a slight tensile stress that causes stress wrinkling of the unsupported aluminum films. Figure 4 is a photograph of a vacuum deposited aluminized Kapton® sample that was placed in a radio frequency plasma environment to completely oxidize the Kapton® over a portion of the sample.

Atomic oxygen undercutting of the double aluminized Kapton® blanket covers for the ISS photovoltaic array box cushions has occurred resulting in a torn and partially detached aluminum film. Based on computational modeling, atomic oxygen atoms that become trapped between the two aluminized films on each side of the Kapton® blanket appear to cause accelerated undercutting damage in comparison to the use of a single top-surface coating.

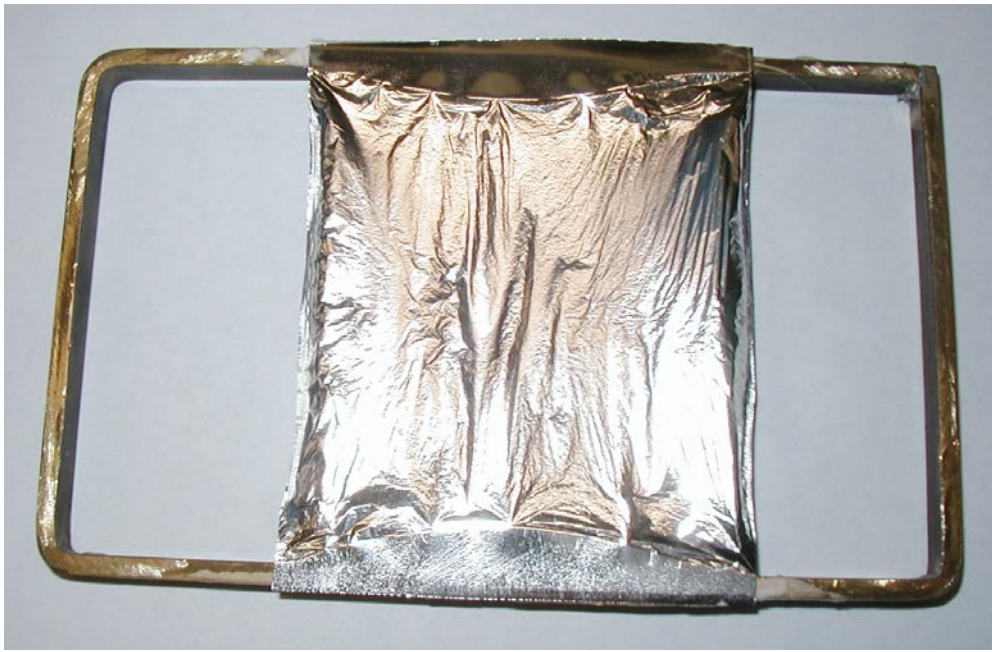
Figure 4.—Photograph of a vacuum deposited aluminized Kapton® sample bonded to a metal frame after ground laboratory oxidation of the Kapton®.

As can be seen in Figure 4, where the ~1000 Angstrom aluminum film in the lower portion of the sample is free standing, stress wrinkles and tears develop similar to those seen in the ISS photograph of Figure 3.

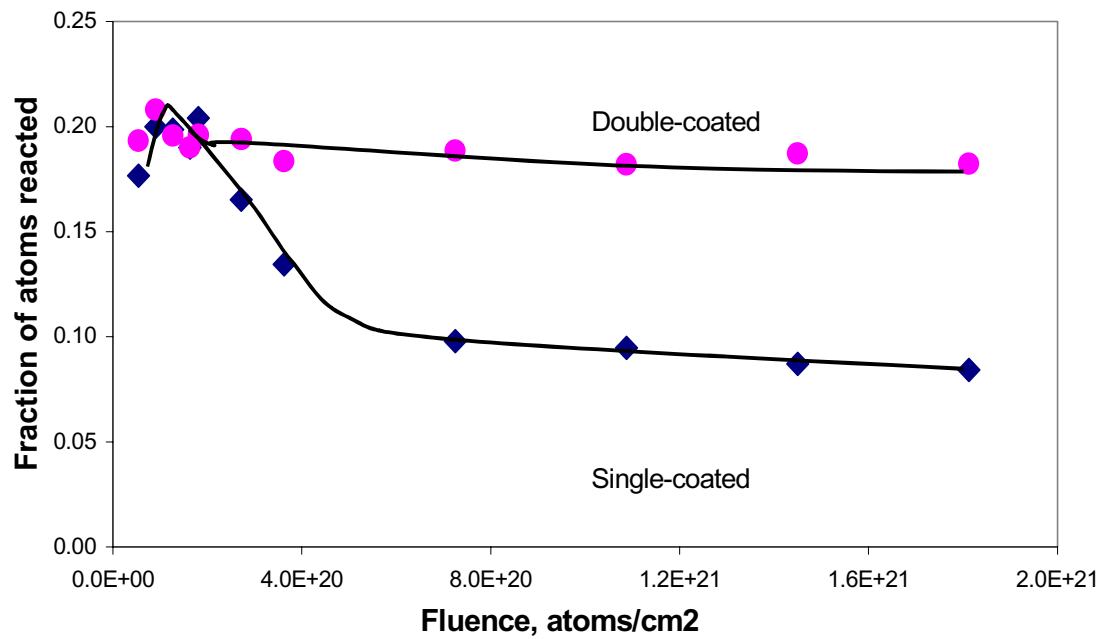
a. 2-Dimensional model of crack or scratch defect

Figure 6.—Computational atomic oxygen erosion predictions for 45-degree incident atomic oxygen attack at defect sites protected Kapton®.

As can be seen in Figure 6, for both 2-dimensional modeling of a crack or scratch defect and 3-dimensional modeling of a circular defect the growth characteristics of the under cut cavity have similar trends with fluence. Initially, as the undercutting starts the existence or absence of the back surface coating plays no role and as the cavity grows the probability of atoms reacting increases due to trapping of the incoming atom. However, as the bottom surface is reached, atoms begin either to escape, or in the case of no back-surface coating, they recombine after collision with the  $\text{SiO}_2$  on the back surface. The double surface aluminized Kapton® consistently reacts more atomic oxygen atoms than the single surface aluminized Kapton® except at very low fluences where the erosion in either case does not reach the bottom of the polymer. For both cases, as the fluence increases, the atomic oxygen can escape out the bottom (only in the case of the single surface aluminized Kapton®), recombine, or thermally accommodate and thus becomes less probable to react with the Kapton®. Thus it appears that a single surface aluminized Kapton® would have been much more durable because the unreacted atoms passing through the bottom of the polymer would simply enter into the open pore foam and gradually react with it, without causing much damage to the aluminized Kapton®.

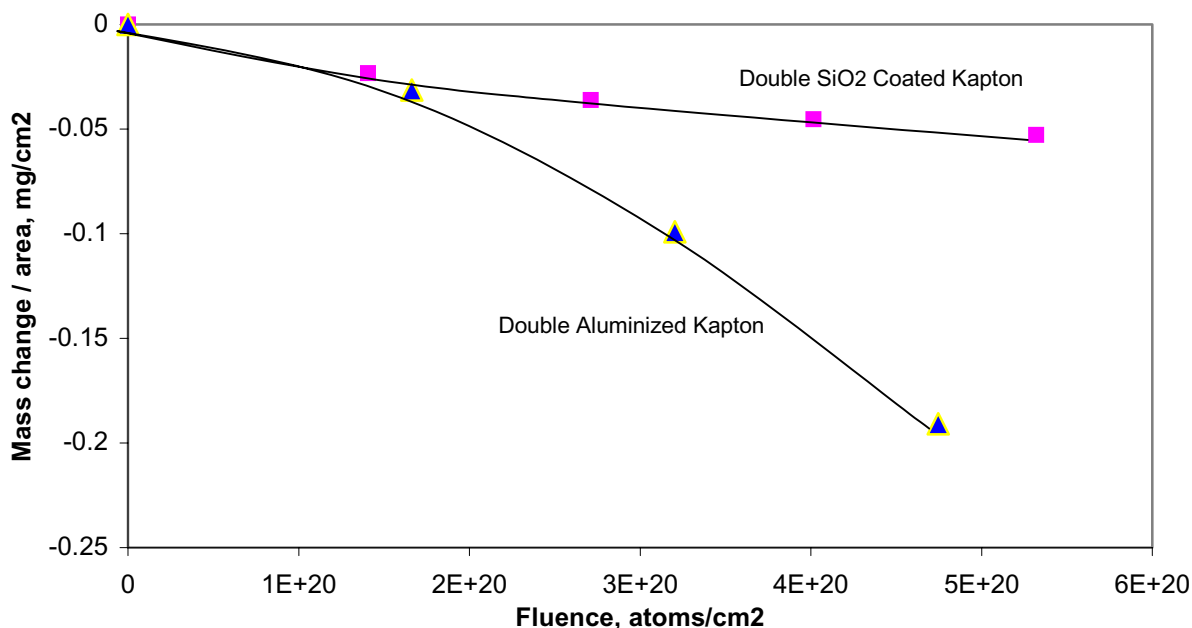
The double- $\text{SiO}_2$  coated ISS solar array blankets may show similar detachment of the outer surface  $\text{SiO}_2$  layer with time. However, the defect density appears to be much lower than for vacuum deposited aluminum coatings as shown in Figure 7 which compares the experimental results of RF plasma oxidation of double aluminized Kapton® with double  $\text{SiO}_2$  coated Kapton®.

Figure 7.—Comparison of RF plasma oxidation of aluminized and  $\text{SiO}_2$  coated Kapton®.
